Cermak Health Services Facility

Date Submitted: December 6, 2023

Submitted To: Cook County

CORRIDOR RAMP ACCESSIBILITY ASSESSMENT

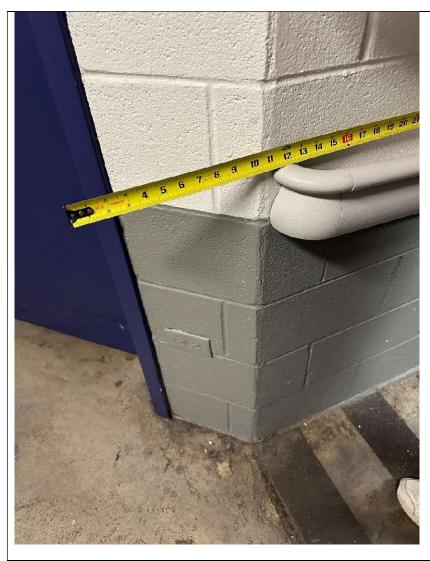
The existing ramp handrails on both sides are not continuous with 12-inch extensions. Therefore, they are not compliant with section 505.10.1 of the 2010 ADAAG, the 2009 ANSI 117.1 Accessibility Standard, nor the 2018 IAC. The existing handrails are located 36 inches above the floor, which complies with all three standards.

4) Handrail at top of Corridor Ramp – Required 12" extension missing (9/1/2023)
